Wandsworth Common Management and Maintenance Plan

Volume 1: Understanding Wandsworth Common

Final Draft

Prepared by LUC in association CFP, Bosky Trees, SYSTRA and Rees Bolter Architects

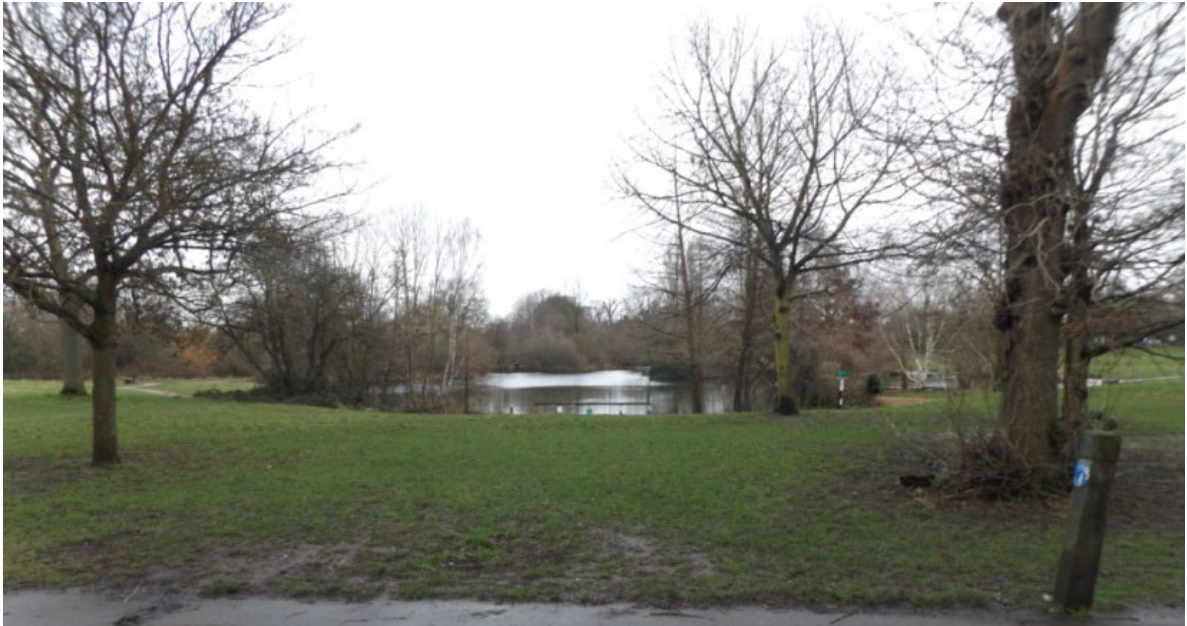
Figure 7.3 Fishing lake viewed from the east

- 7.17 The lake level is allowed to drop from its wet-weather level by up to 10" in drier periods before the Council tops the pond up using a mains feed. This typically takes place three or four times a year and involves lifting the water-level back up by about 5-6" which corresponds to a level just below the overflow crest. Each fill takes about a day to complete.
- 7.18 During particularly severe wet weather, the wildlife lake has been known to overflow at the northern end, allowing water to flow along the adjacent path to a low point towards the railway footbridge and down onto the railway cutting (**Figure 7.5** overflowing water flows along path in background towards the left direction. Railway cutting is beyond the fence).

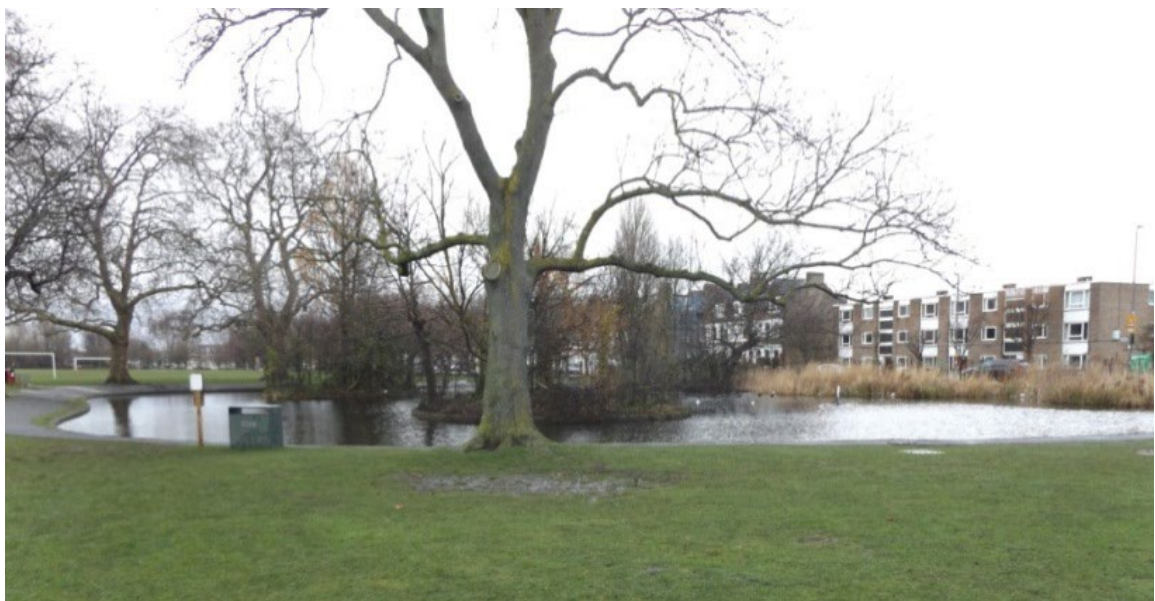
Figure 7.6 Three Island Pond

- 7.19 The Three Island Pond also has no apparent formal water feed, though there is an inlet believed to be from an old land-drain system serving some of the nearby pitches. The system's age is unknown and it is no longer reportedly effective. The pond is also believed to be affected by groundwater levels, although it has not known to overflow.

- 7.20 An aerator pump has been installed in Three Island Pond and runs continuously. Previous attempts to aerate the Pond (and the lakes) naturally using underwater vegetation have been

unsuccessful as it has been eaten by waterfowl. The Pond's water level drops in similar manner to that in the lakes in drier periods and requires occasional top-up from a mains feed.

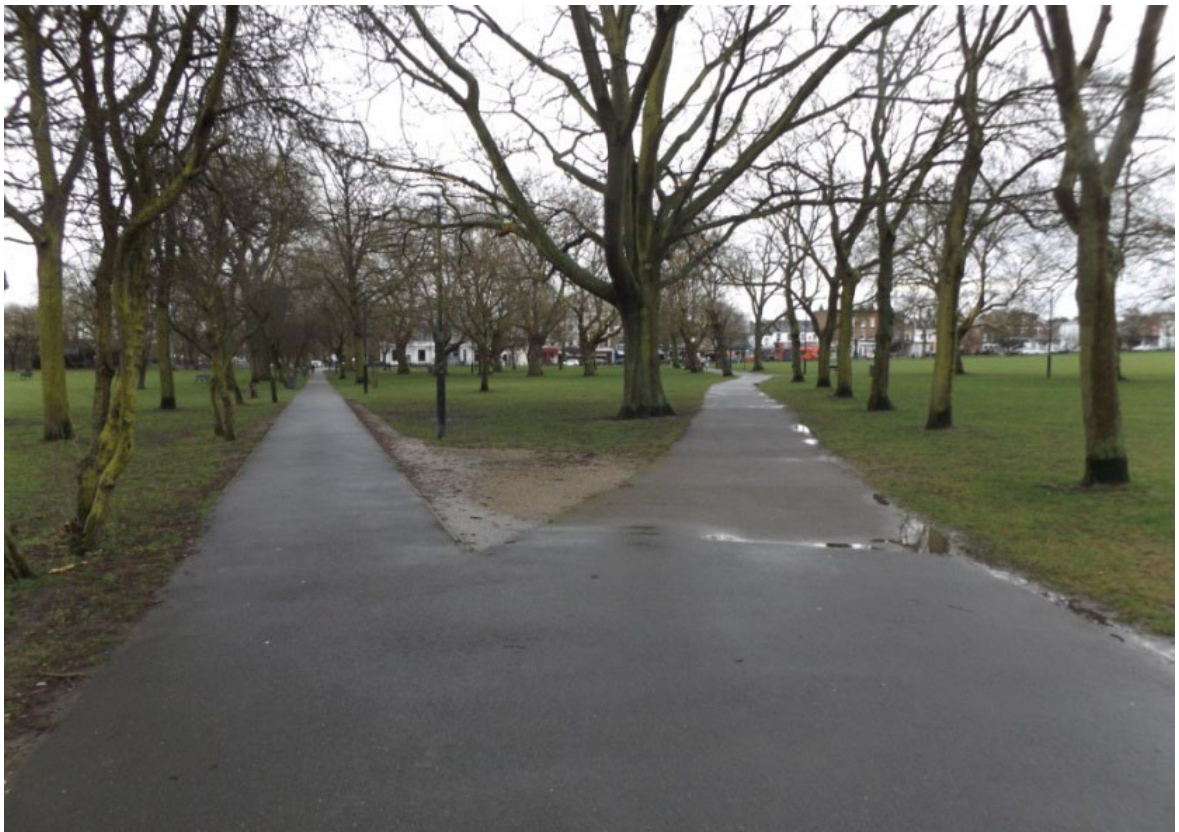
Figure 7.9 Footpaths near Bellevue Road showing typical marginal conditions

- 7.25 The margins to the various paths across the Common do not suffer greatly from run-off damage exacerbating soft ground.

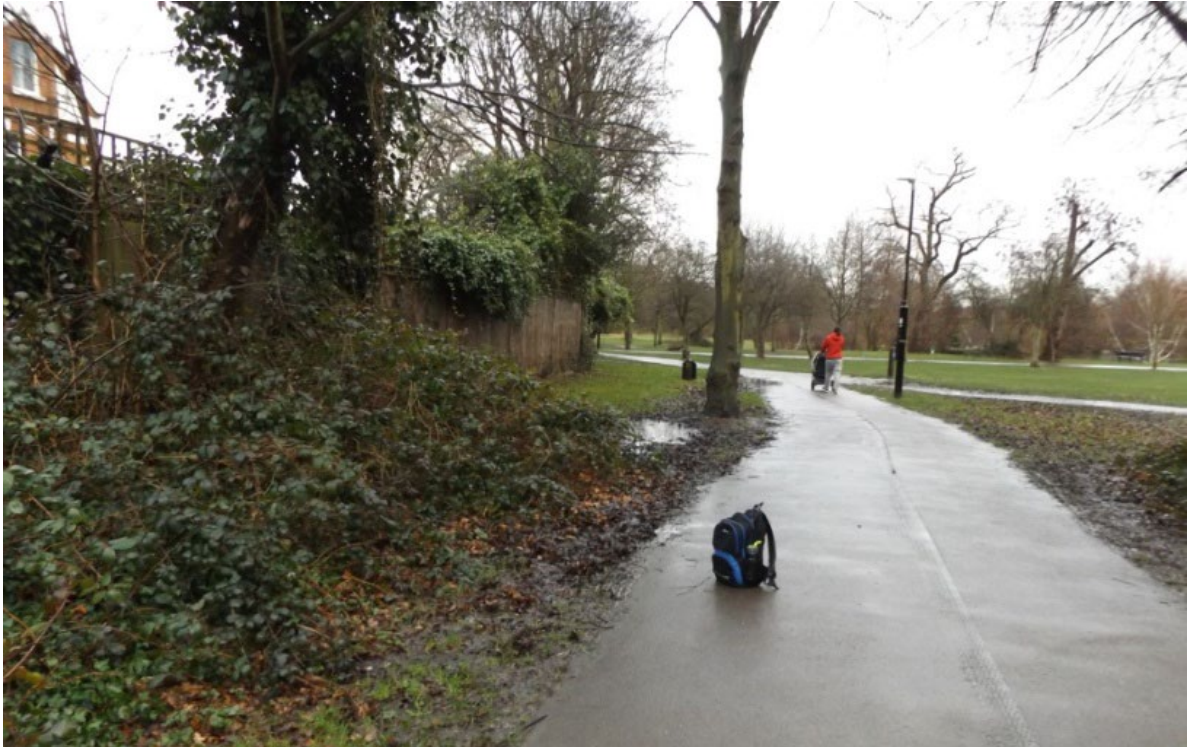
Figure 7.10 Location of waterlogged land

- 7.26 There is one location where marginal ponding and water-logging is a particular problem, to the point that it has generated occasional comments from local residents, beside a junction of paths behind housing at the corner of Routh Road and Baskerville Road. There is no obvious source of greater-than-usual run-off and it may simply be no more than the local path levels holding slightly more water back on the outer margin of the path surface that exacerbates waterlogging of the soil and/or a patch of soil that is locally less pervious.

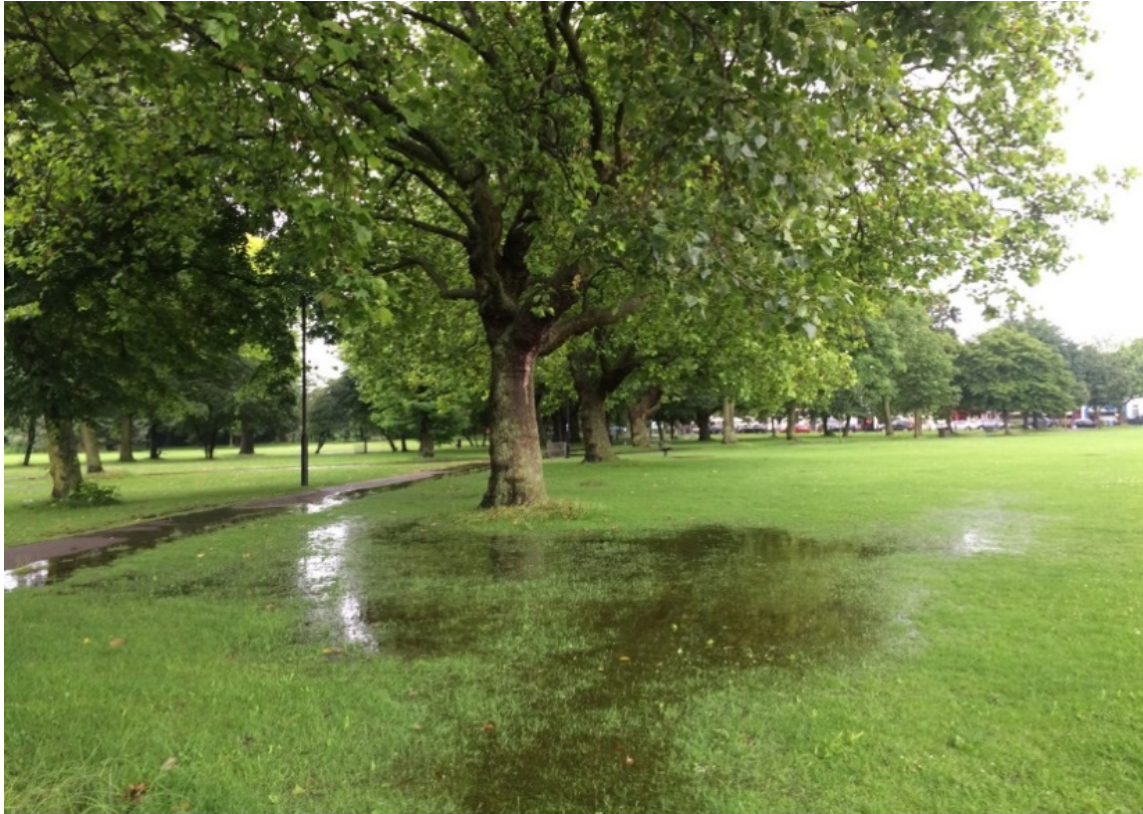
Figure 7.12 Puddling after heavy rain on Bellevue Fields near junction (MAC/FOWC)

- 7.27 Occasional local ponding or waterlogging has also been reported during the consultation process on areas adjoining the paths leading northwards from Bellevue Road and abutting Trinity Road on the south-western side of Bellevue Fields. The field south of the café and north of the lakes and the margins of the cricket-pitches field are also reported as being prone to waterlogging and/or suffering from high levels of informal use (e.g. personal trainers and their clients) during such conditions. Compaction is made worse by runners frequently jogging alongside the surfaced paths in several locations across the Common, as well as areas where groups gather such as outside the playground.

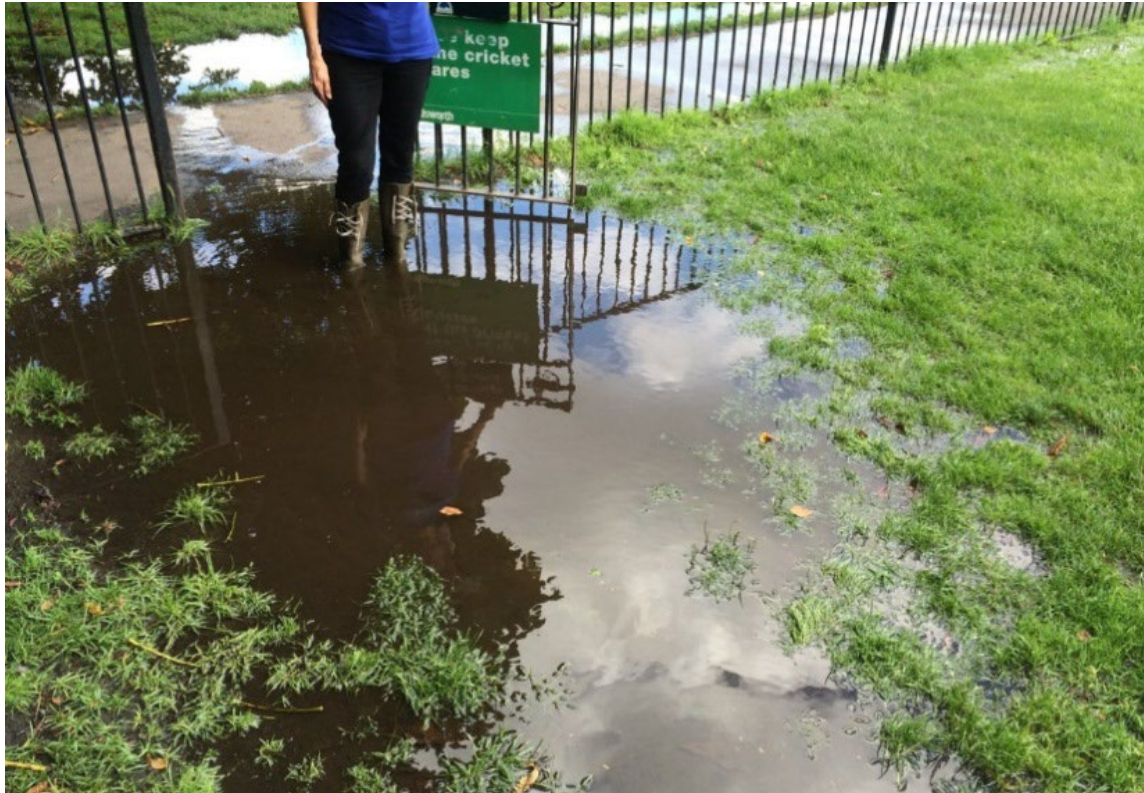
Figure 7.13 Puddling and surface flows on edge of cricket pitch, (MAC/FOWC)

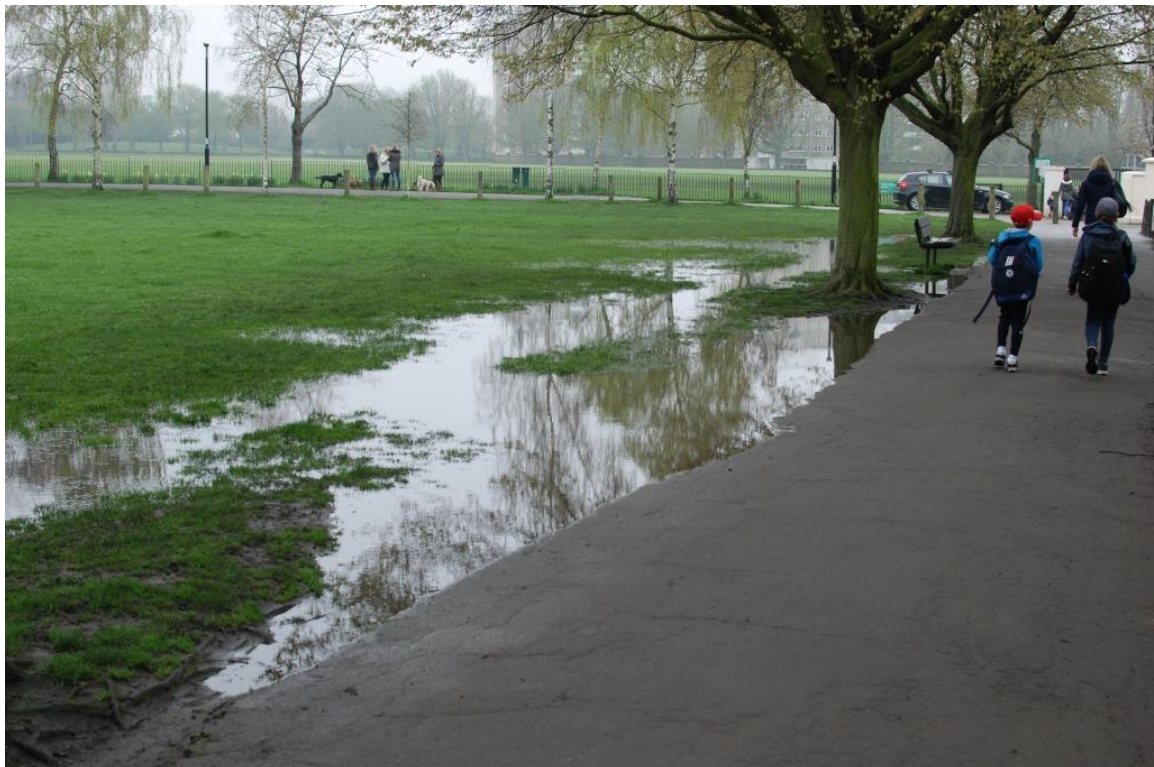
Figure 7.14 Surface ponding near café (out of view to right)

- 7.28 Ultimately, even unpaved land will be unable to accept rainfall in the most severe conditions without generating some surface flows, whether from waterlogging or from sheer intensity of rainfall exceeding the rate at which the water can physically soak into the soil. The behaviours exhibited in these pictures are natural at least in part but the Common's usage contributes to this behaviour by compacting unpaved surfaces so that they lose some of their natural function in this respect. An expectation that the Common remains well-drained and free from surface ponding in

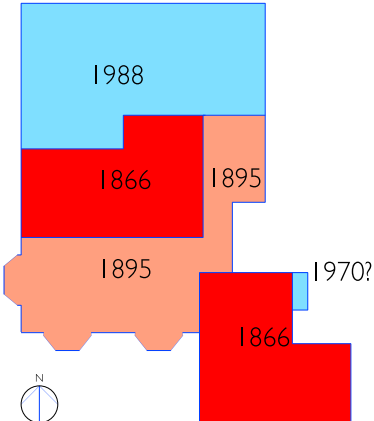
<p><i>Outline of phasing</i></p>

Built structure	Description	Image
Skylark Café / Neal's Lodge and Neal's Cottage	<p>A complex group, formerly the farmhouse of the farm leased to Mr Neal in 1885, and became known as Neal's Farm. Mapping of 1866 shows the footprint of two L shaped buildings, which by maps of 1895 had been connected but were probably still laid out as two domestic properties. The status of the larger property increased through the addition of bay windows and substantial additional rooms. Large northward extension of about 1988 increased the building footprint to the current café capacity.</p> <p>The current layout comprises a café on most of the ground floor entered from the west and north and two self-contained vacant dwellings entered from the east. Internal repair works to the dwellings were commenced but have been suspended pending legal action over proposed use of the buildings.</p> <p>Condition: Fair except for the incomplete internal repairs to the dwellings.</p> <p>Significance: Some significance as the former farmhouse and as an architectural focal point for the buildings on the common.</p> <p>Potential: Uses of the currently unoccupied areas are likely to be dependent on the outcome of recent legal action.</p>
